Manhole Inspection Summary

Manhole # S39G__036MH

Insp Date: **7/14/08 2:54 PM**

Location Address: **200 E Pratt**

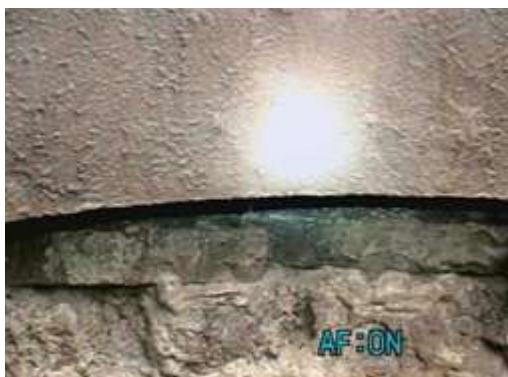
Miscellaneous

chimney joint

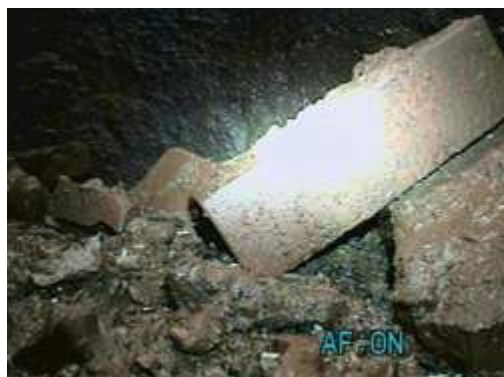
Defect 4

Condition: ☐ Sound ☐ Cracked ☐ Root Intrusion ☐ Deteriorated ☐ Leaks ☒ Debris

channel debris

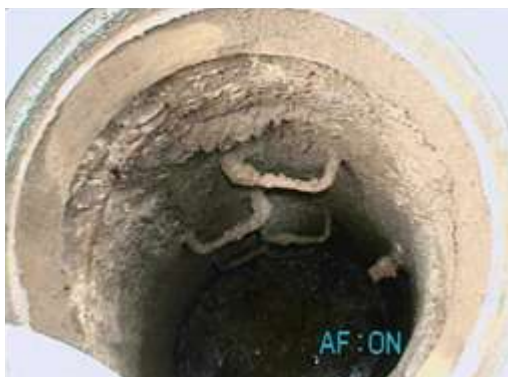
Defect 3

Infiltration: ☐ None ☐ Joint ☐ Cracks ☐ Mortar ☐ Roots ☒ Wall

Count: **5** Missing: **0** ☒ Corroded

corroded steps, infiltration on corbel & barrel walls

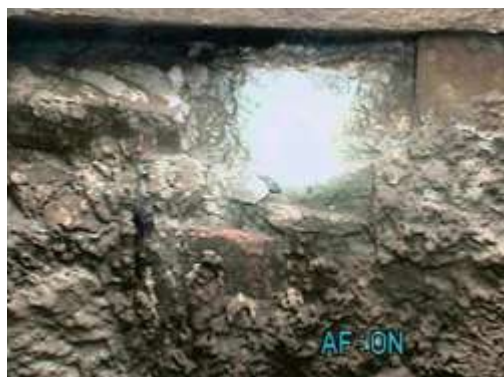
Defect 2

Condition: ☐ Sound ☐ Cracked ☐ Root Intrusion ☒ Loose Brick ☒ Deteriorated

Infiltration: ☐ None ☒ Joint ☐ Cracks ☒ Mortar ☐ Roots ☐ Wall

chimney cond loose bricks, & deteriorated with infiltration from joint & mortar

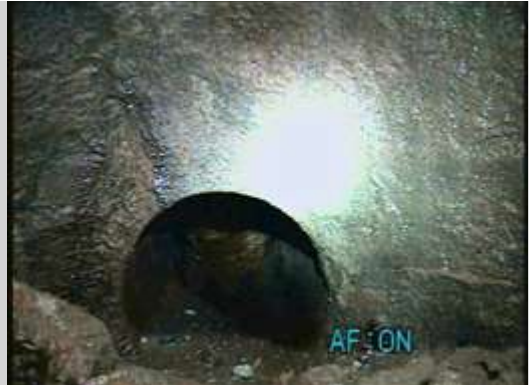
12 O'Clock Outflow

8 in. Circular Gravity Sewer
Pipe Out @ 12 O'Clock

Deposits: ☐ None ☐ Mud ☐ Sludge ☒ **Debris** ☐ Grease

Silt Depth: **3** (in.) Deposits Extent: **Light**
